# Uniform Mitigation Verification Inspection Form

Inspectors Initials SR Property Address 6911 Grand Estuary Trail

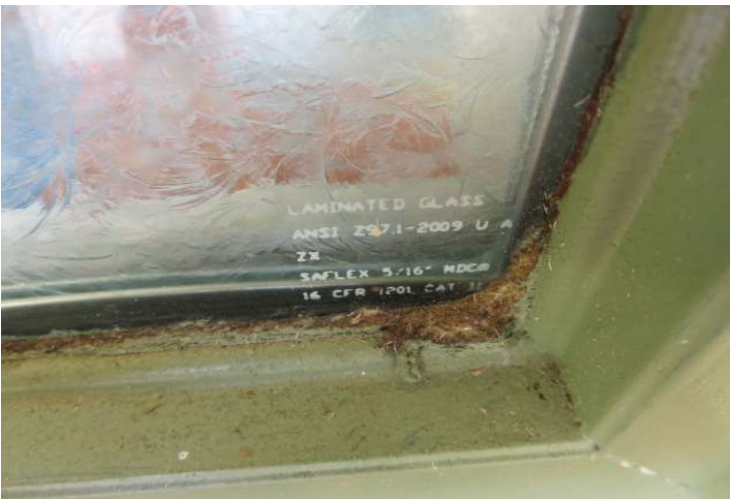
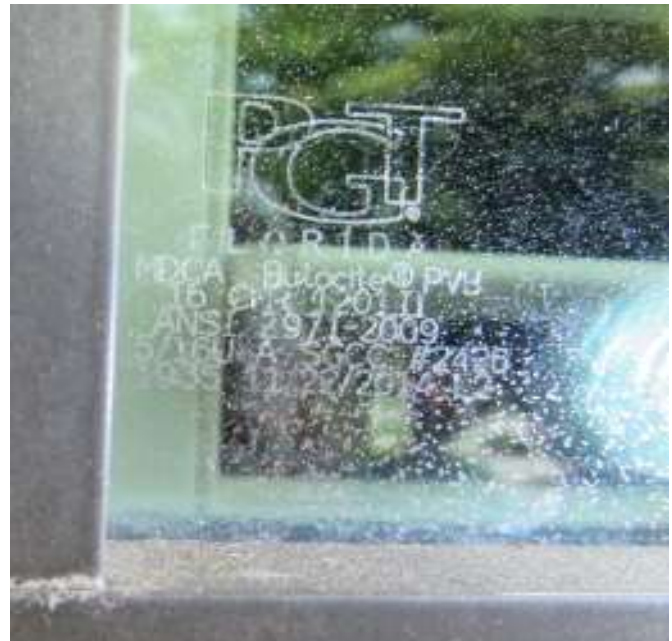
All other openings are glazed and impact rated - LAMINATED GLASS - MDCA -
