Uniform Mitigation Verification Inspection Form

Inspectors Initials SR Property Address 6918 Grand Estuary Trail

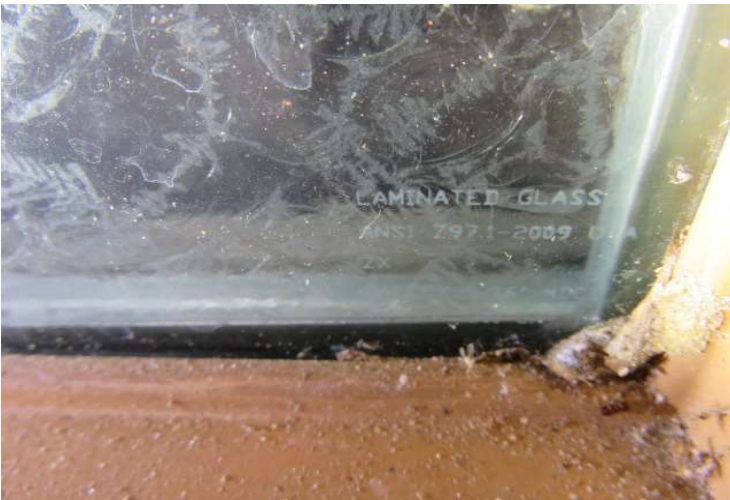
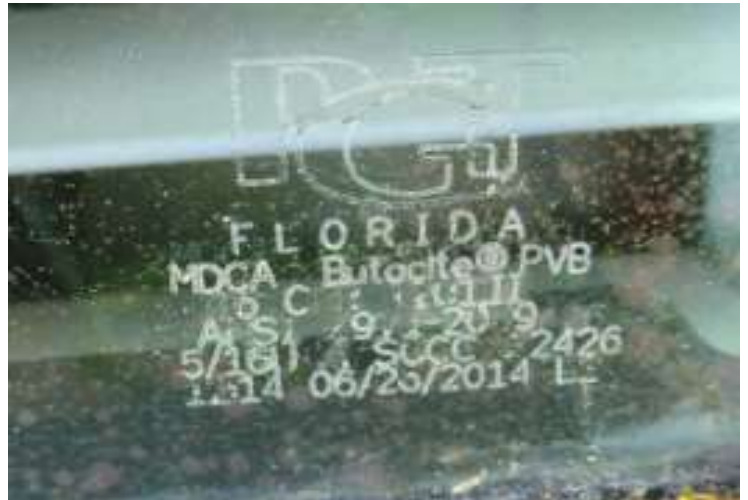
Balance of openings are glazed and all are impact rated - LAMINATED GLASS - MDCA -
