# Uniform Mitigation Verification Inspection Form

Inspectors Initials SR Property Address 7005 Grand Estuary Trail

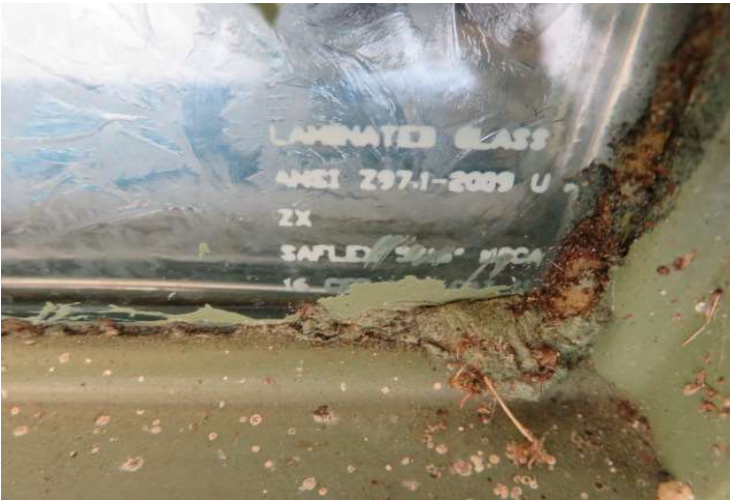
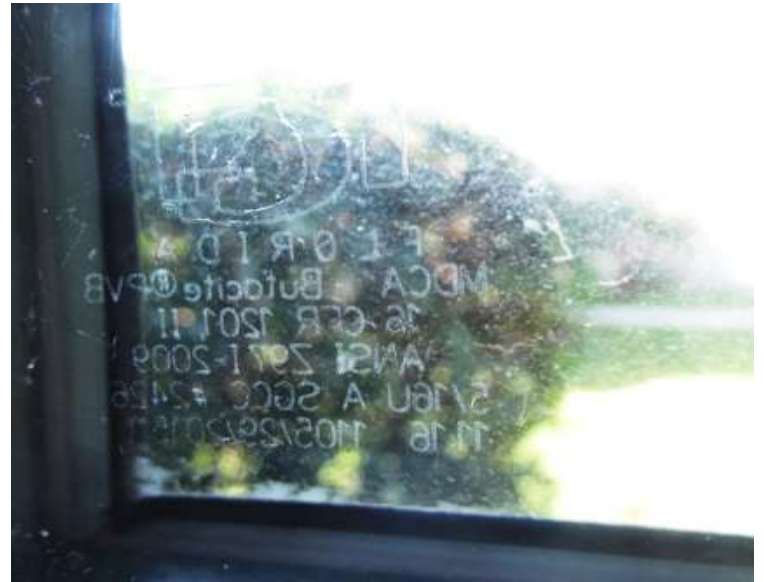
Balance of openings are glazed and all are impact rated - LAMINATED GLASS - MDCA -
